Rimkus Consulting Group, Inc.
Eight Greenway Plaza, Suite 500
Houston, TX 77046
(800) 580-3228 Telephone
(713) 623-4357 Facsimile

Re: RCG File No: 11009971
LLV Number: 0209452
VMF Location: 1530 Greensmark Drive in Houston, Texas
Subject: Final Report

Rimkus Consulting Group, Inc. was retained to examine LLV 0209452, VIN 1GBCS10E4M2908832. The fire occurred on June 13, 2016 at around 12:30 P.M. the operator of the vehicle at the time of the fire, was unavailable for interview but reportedly stated the vehicle's engine died while delivering mail on his route and backfired during subsequent attempts to restart it. Soon thereafter, smoke was observed from beneath the hood as well as flames.

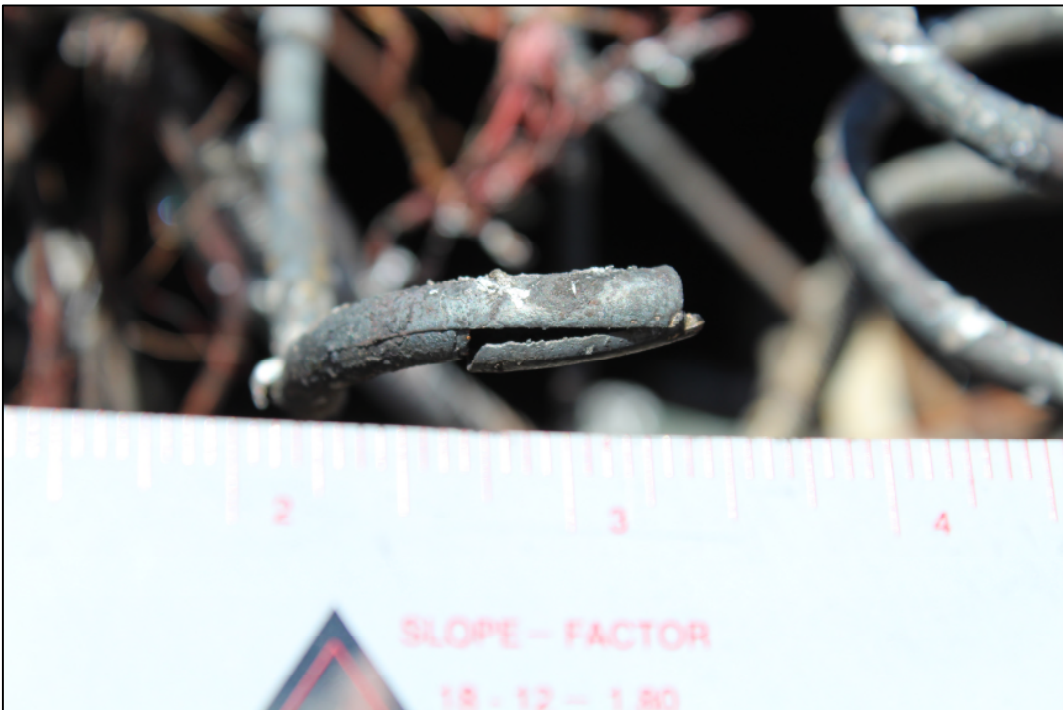
Photograph 19

Close up photo of break in line with separation from other end.

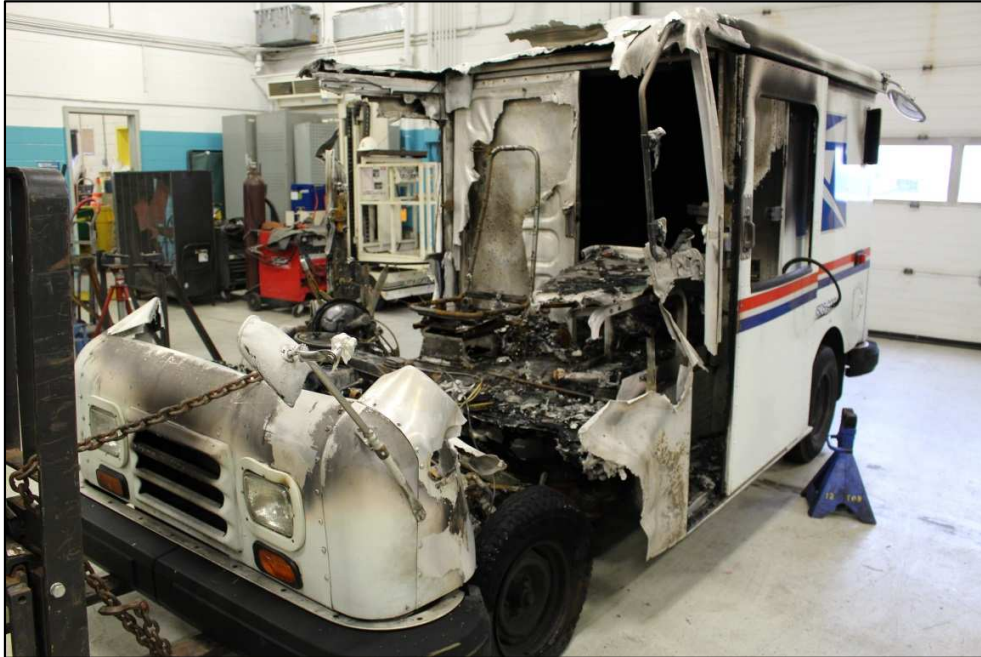
Photograph 1

Exterior view of the left side of the vehicle.

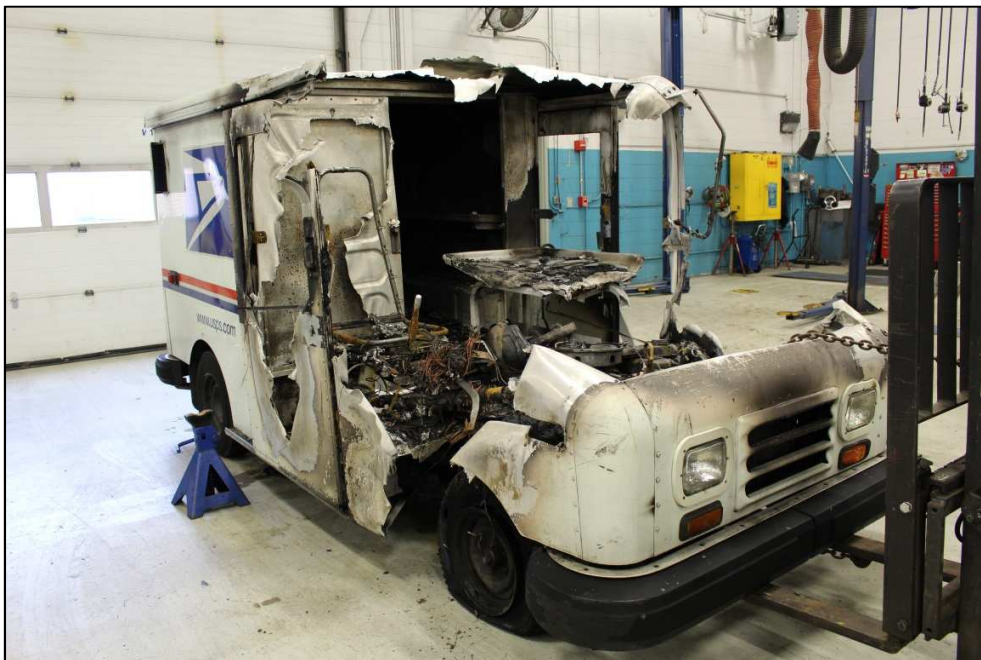
Photograph 2

Exterior view of the right side of the vehicle.

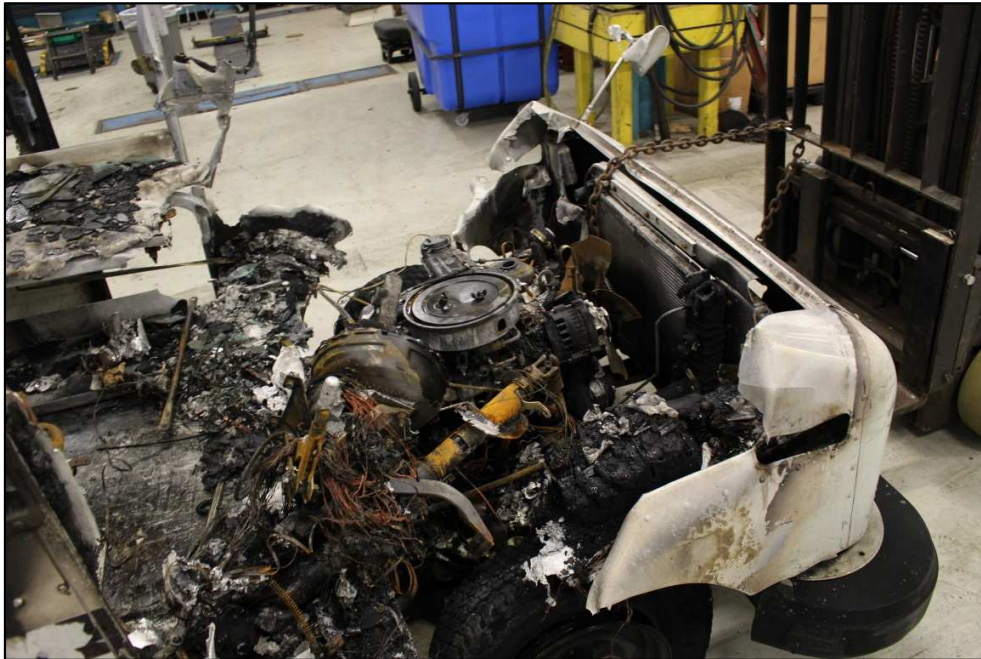
Photograph 3
View of the engine compartment.

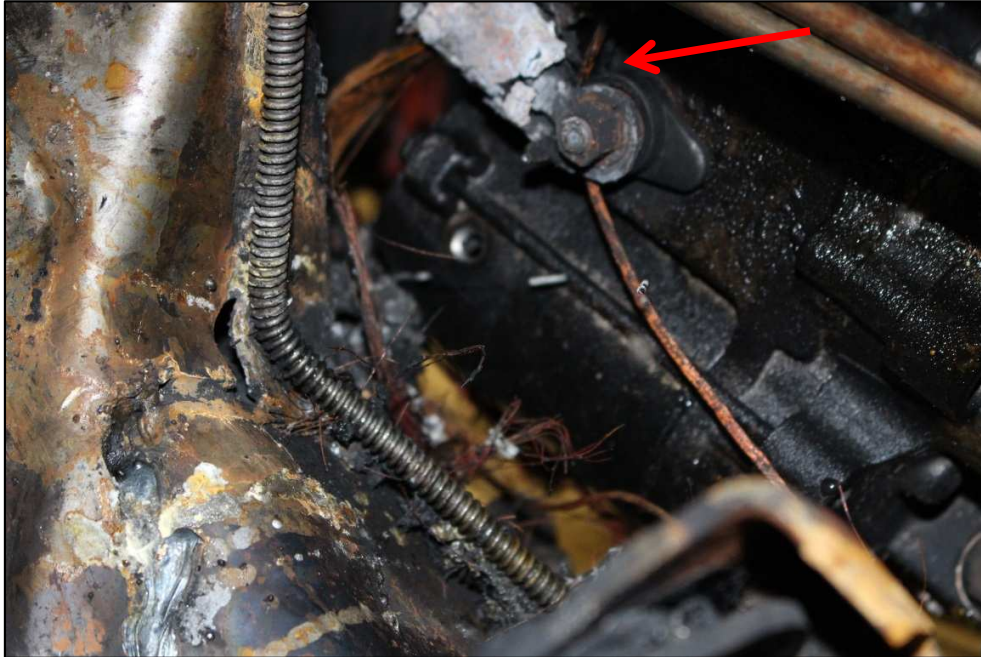
Photograph 5

Positive battery cable to the starter and the solenoid conductor in contact with each other

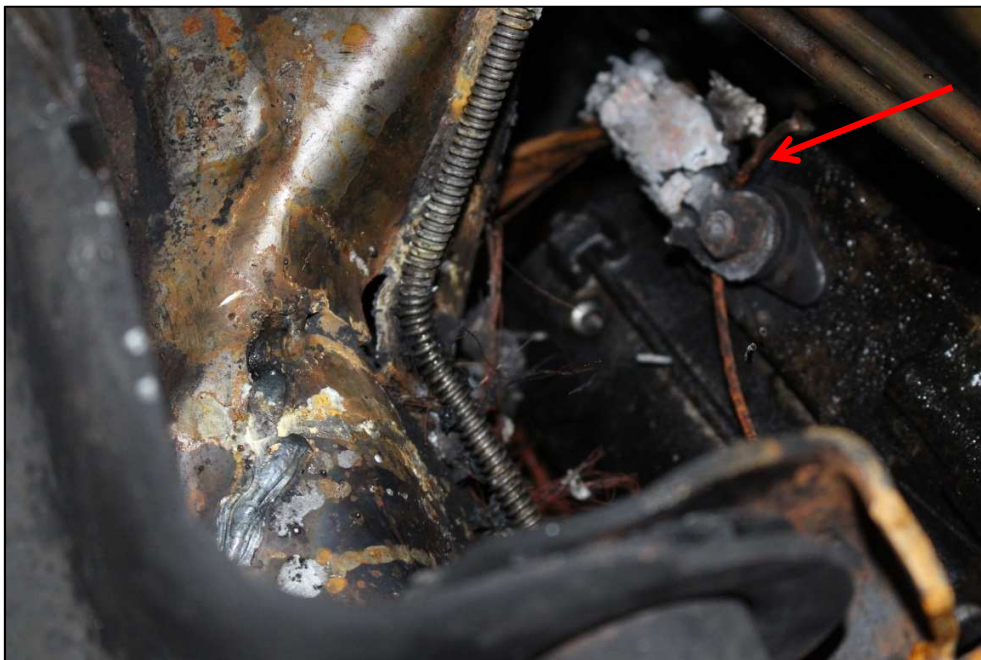
Photograph 6

Close-up view of the contact made between the cable and conductor.

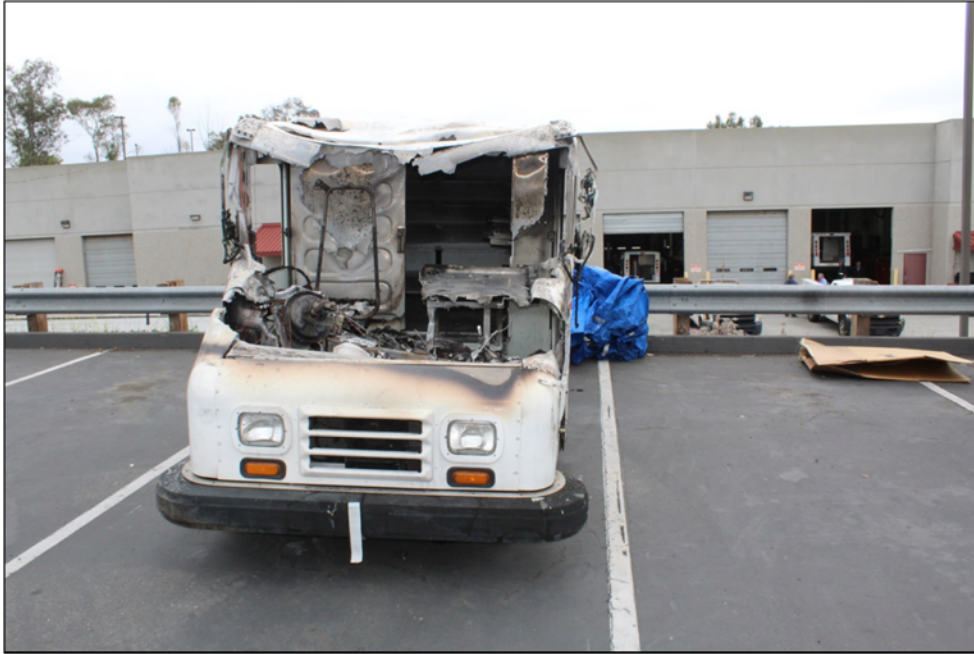
Photograph 1
Front view of LLV 1263299.

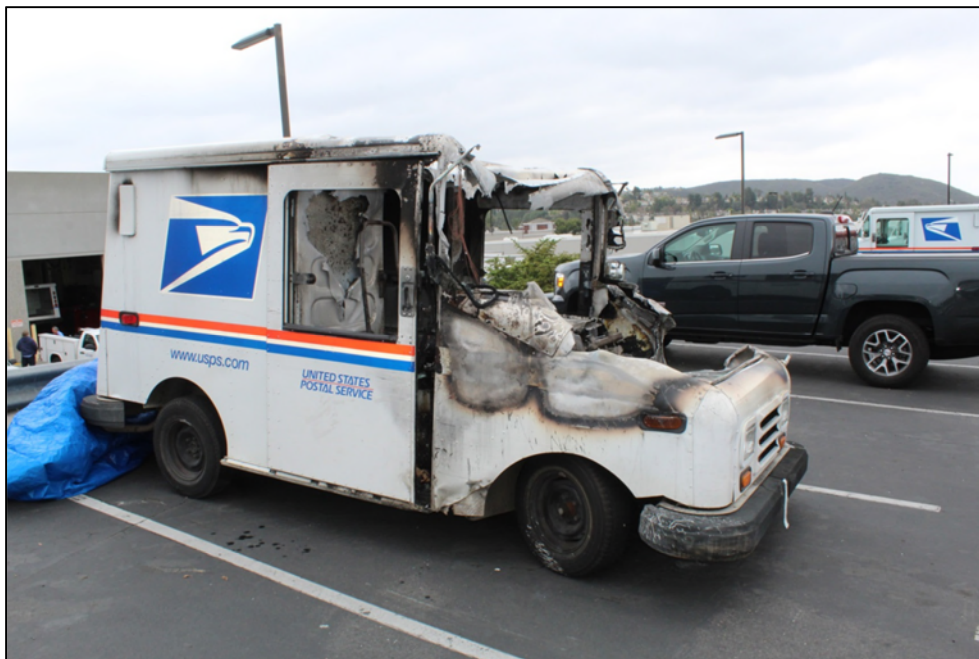
Photograph 2
Driver's side view.

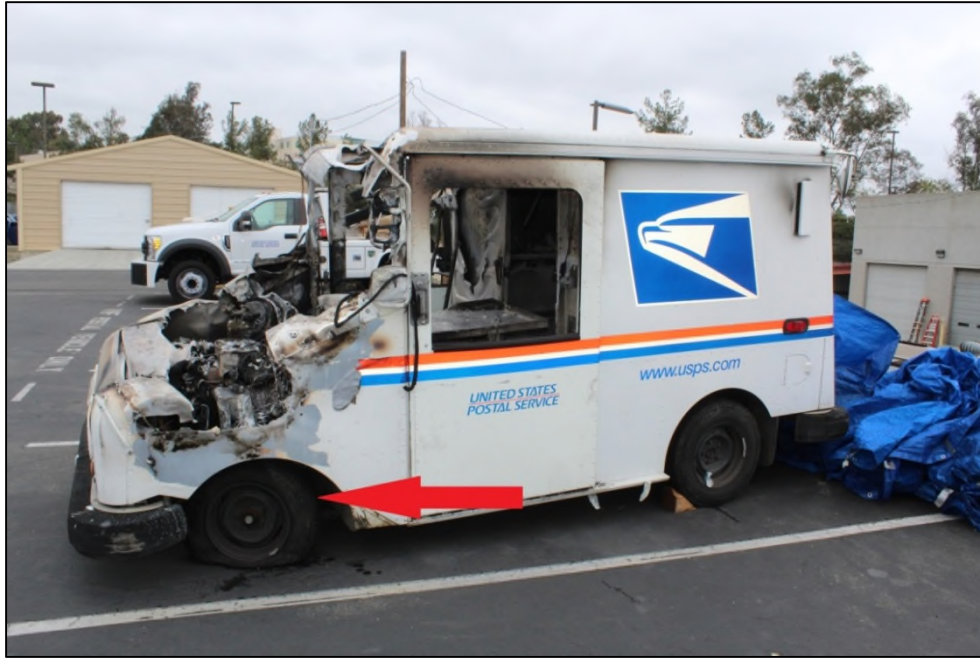
Photograph 3

Mail side with flat front tire (red arrow).

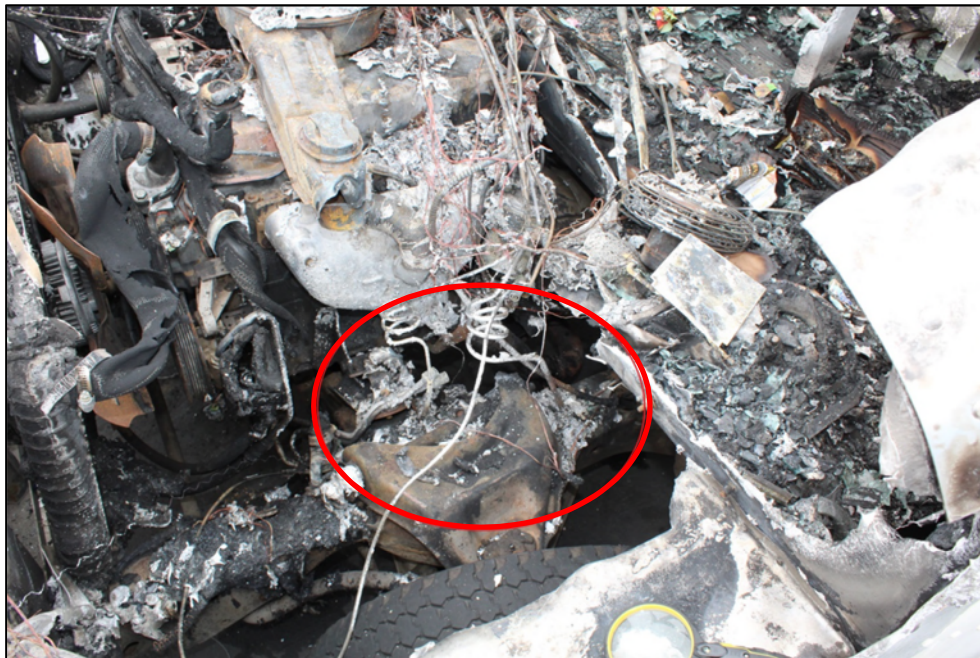
Photograph 4

Area of fire origin in red circle.

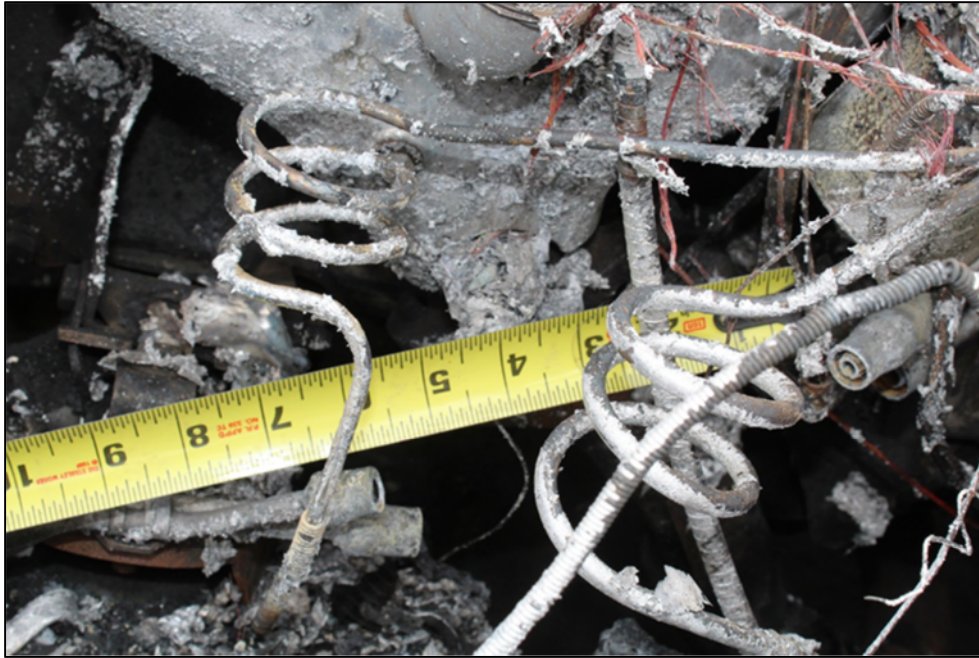
Photograph 5

Six inch gap in fuel lines where flexible fuel hoses were missing.

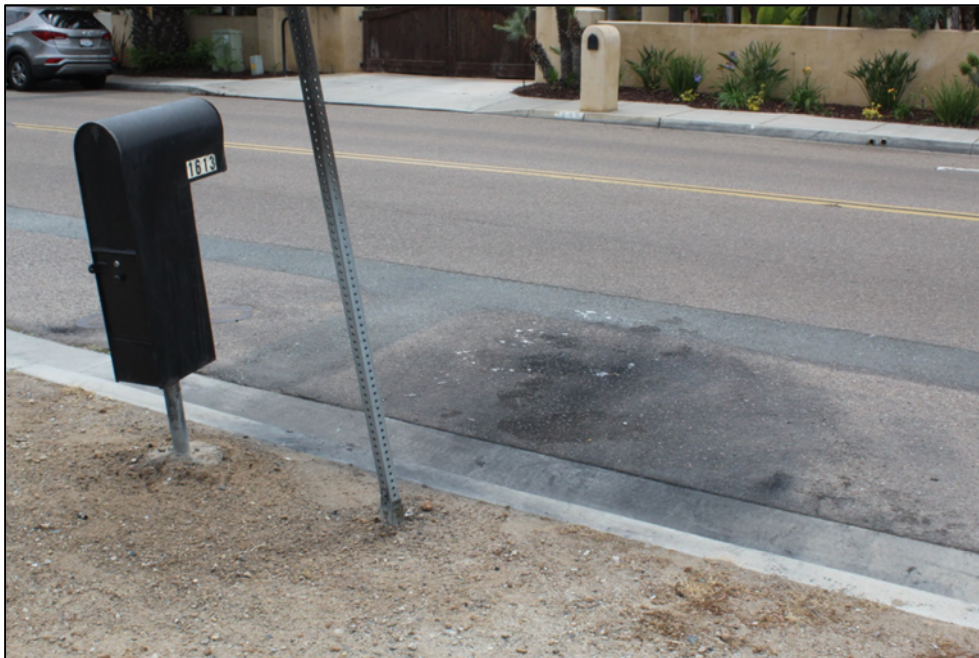
Photograph 6

Fire scene on Lake Drive, Encinitas.

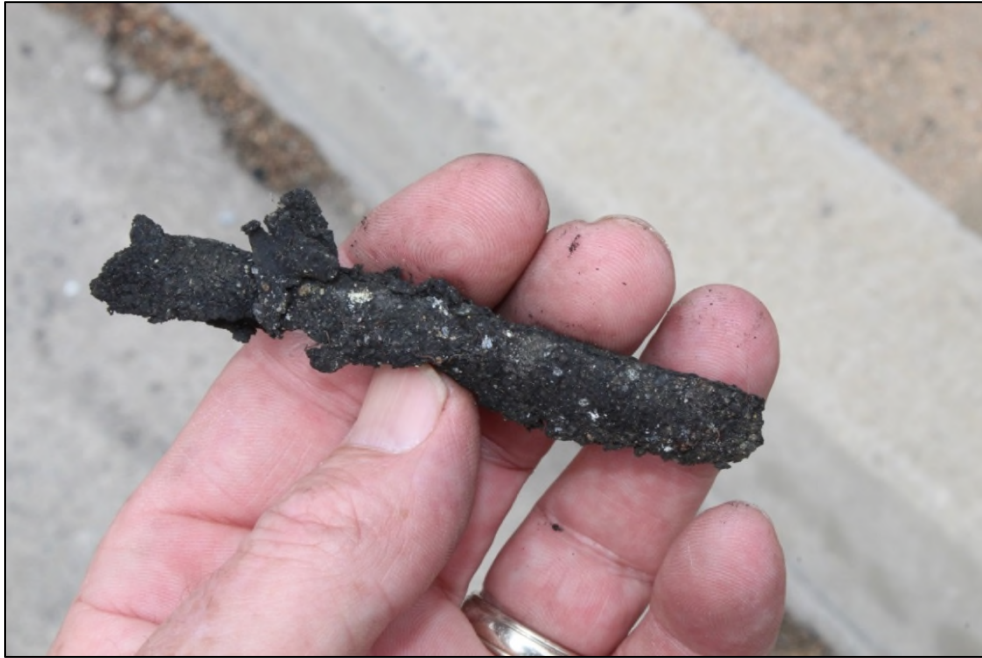
Photograph 7

Burned fuel line from fire scene on Lake Drive, Encinitas.

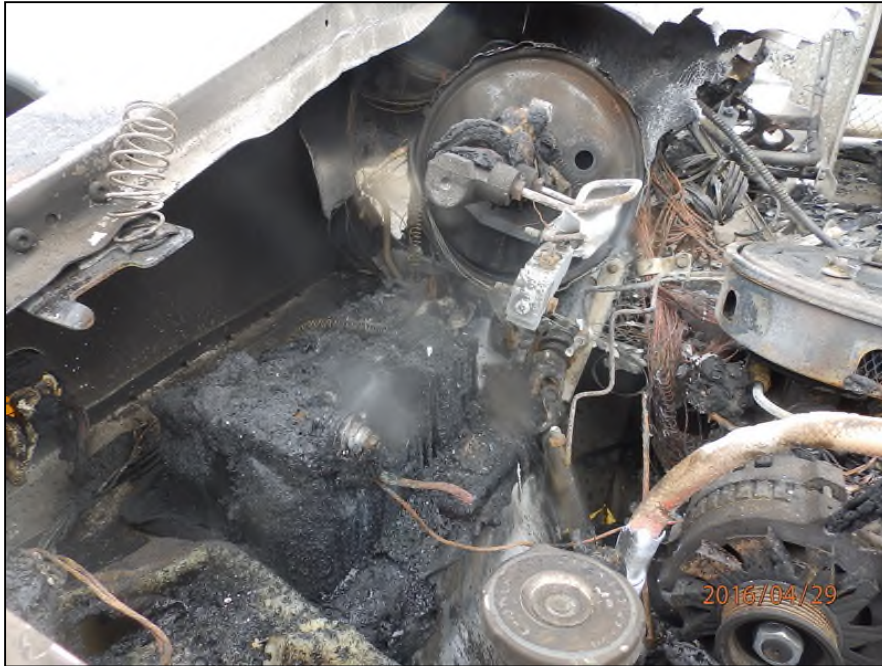
Photograph 1

A view of the right side of the engine compartment.

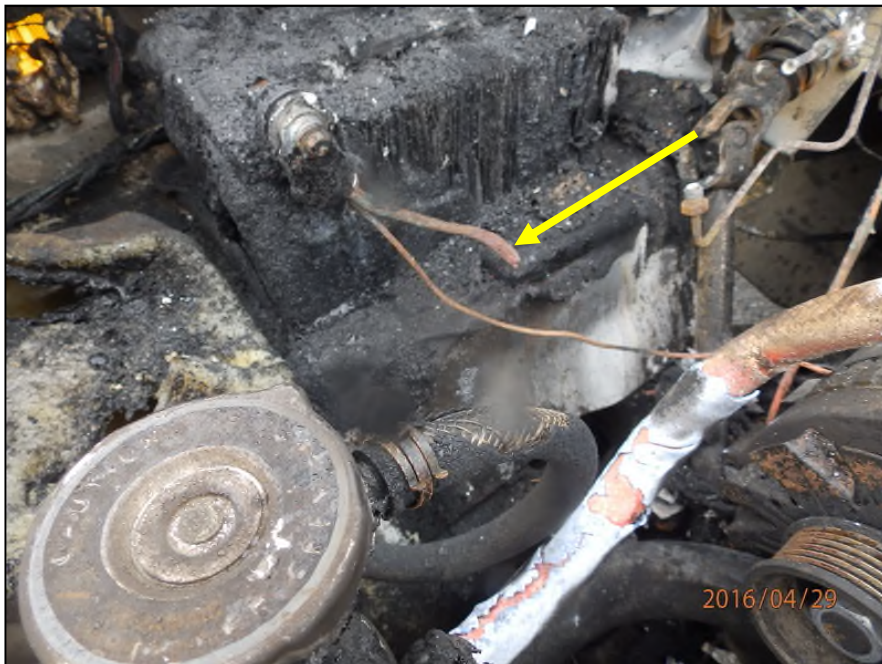
Photograph 2

A view of the battery and conductor to starter.

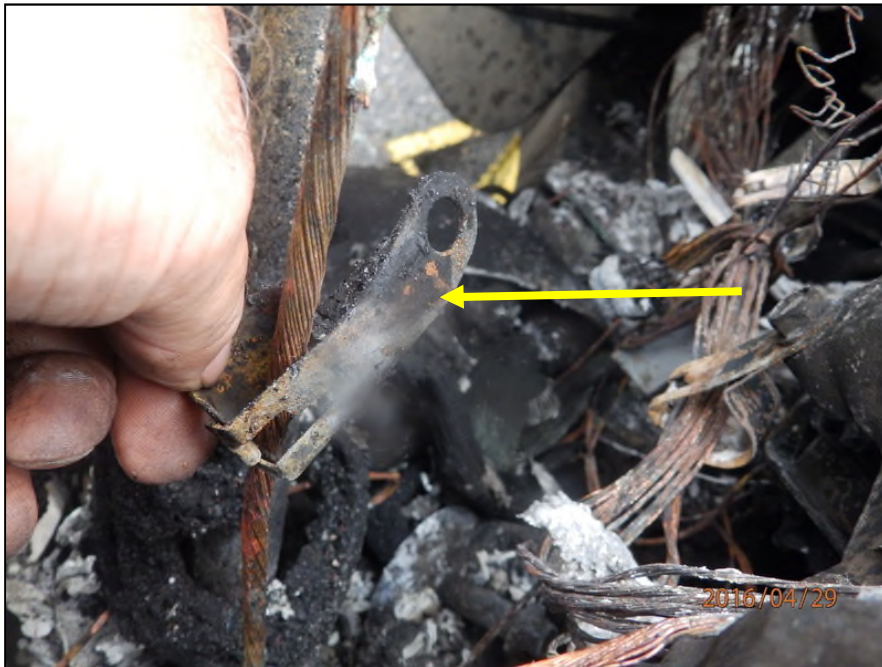
Photograph 3

The loom which previously held the conductor.

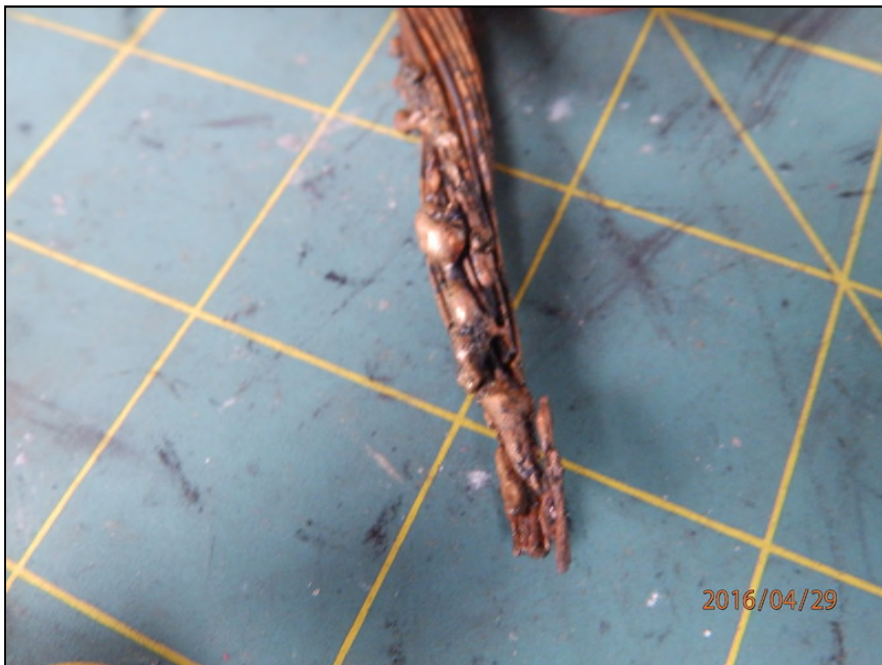
Photograph 4

A view of the conductor from the battery to the starter.

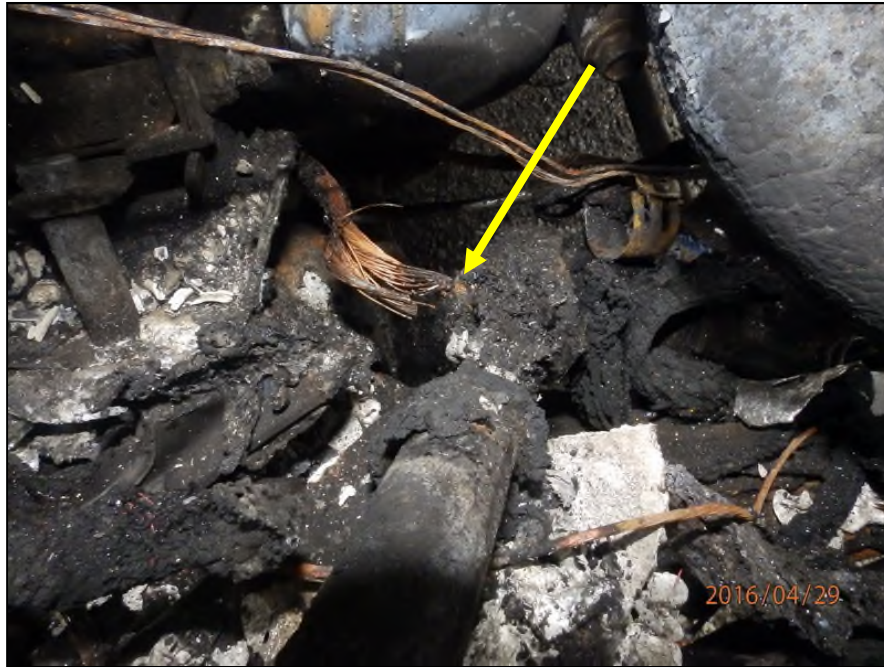
Photograph 5

A view of the conductor fused to the steering linkage.

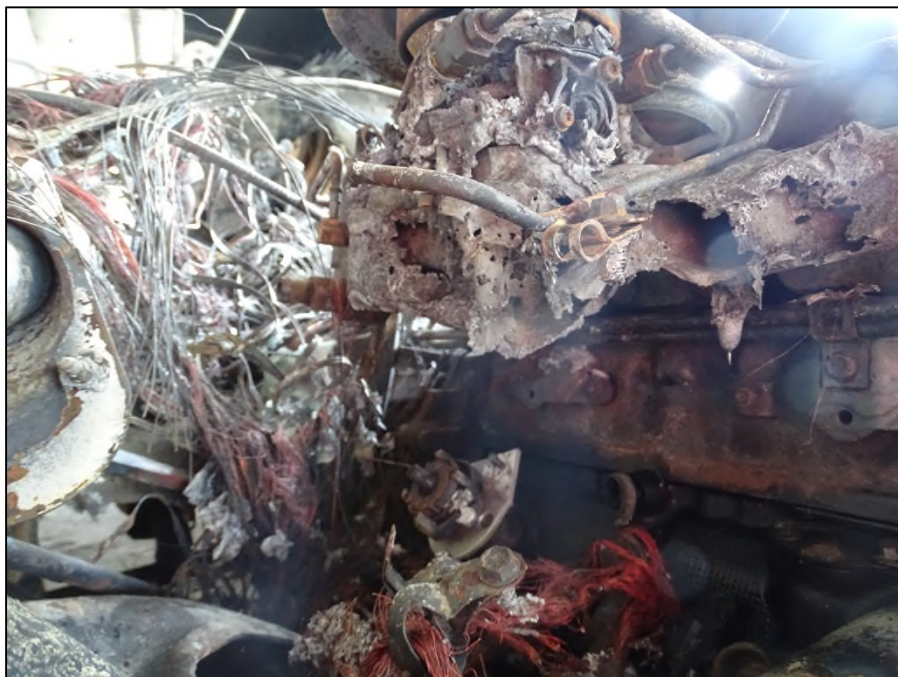
Photograph 6
Thermal damage to front part of throttle body.

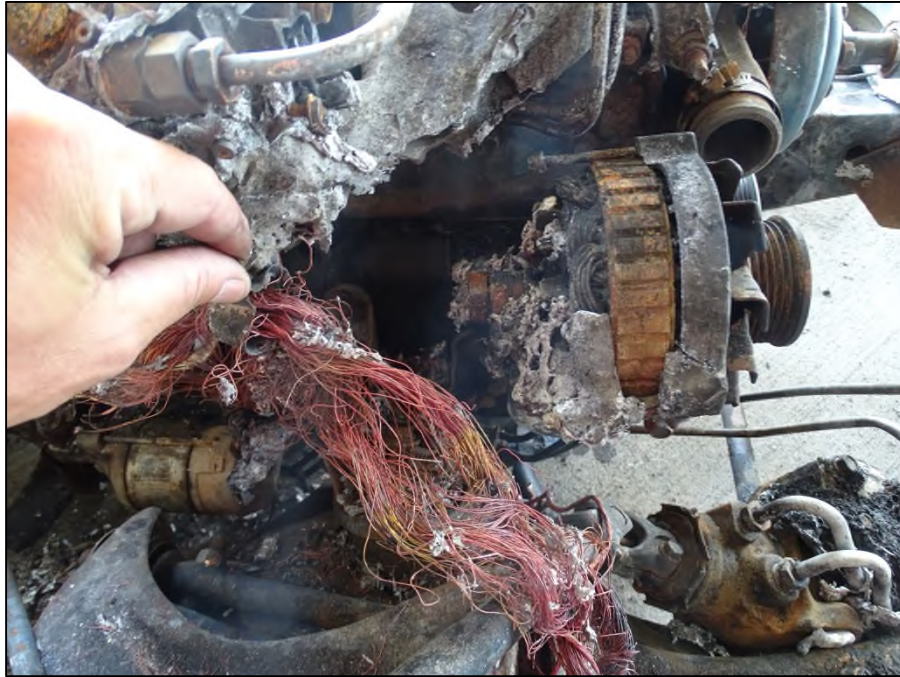
Photograph 9

Area where battery cables where mounted on throttle body.

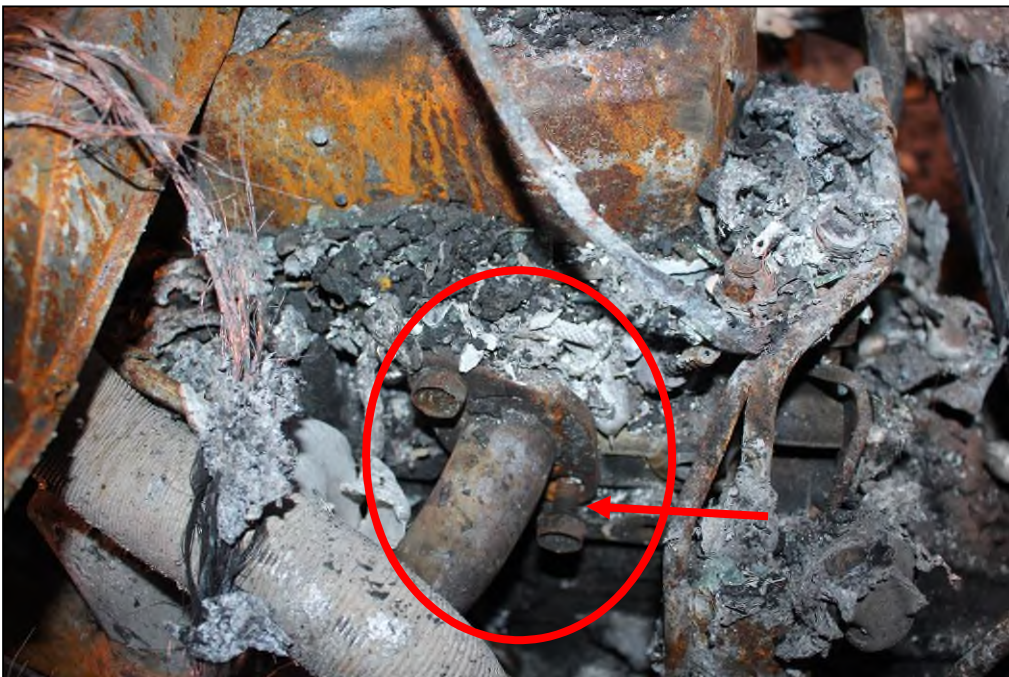
Photograph 4

2. The specific area or origin within the engine compartment was determined to be in the area of the fuel lines and the exhaust manifold.
3. The specific ignition sequence and cause of the fire was determined to be the direct result of a failure of the rubber fuel lines in the area of origin which allowed atomized gasoline to be sprayed onto the hot surface of the operating exhaust system and ignite.

View of the rear left side of the engine with the loose bolt in the exhaust manifold.

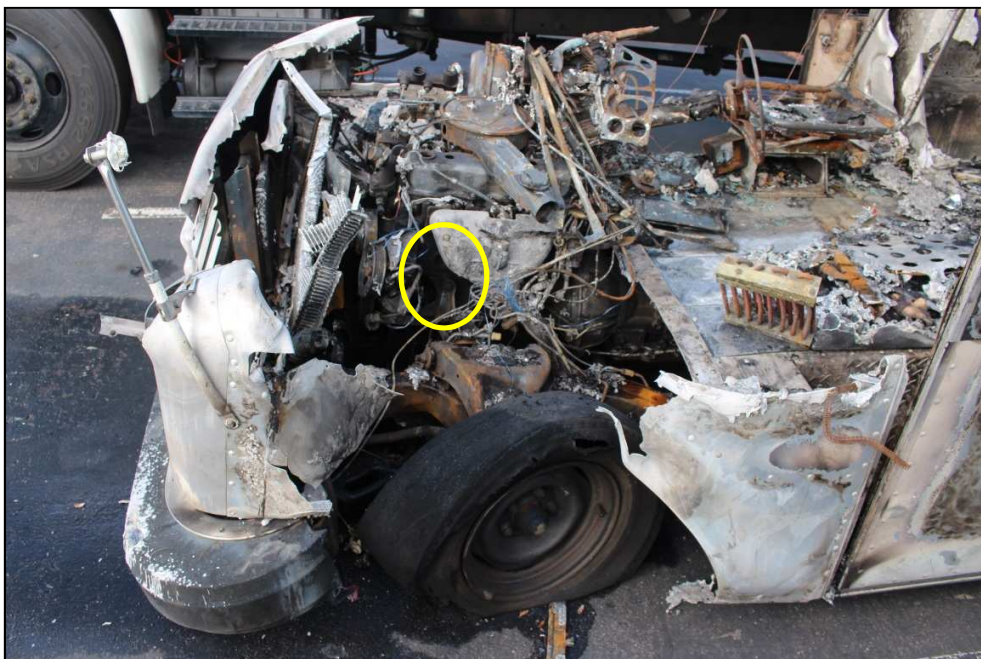
Photograph 2
Engine compartment, left side. Hole in engine block, yellow circle.

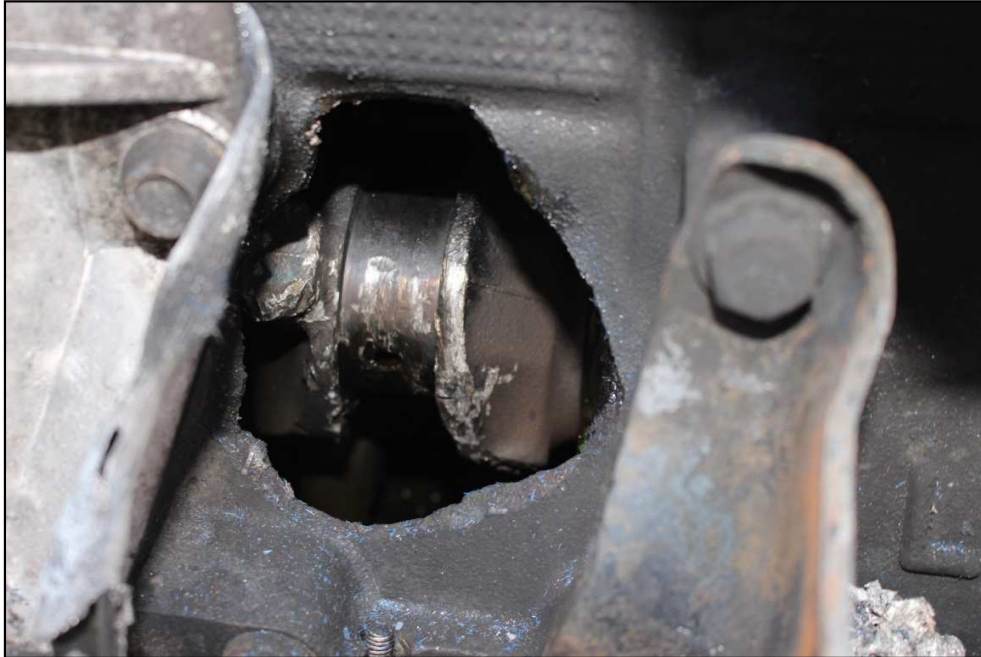
Photograph 3

Hole in engine block and damaged crankshaft.

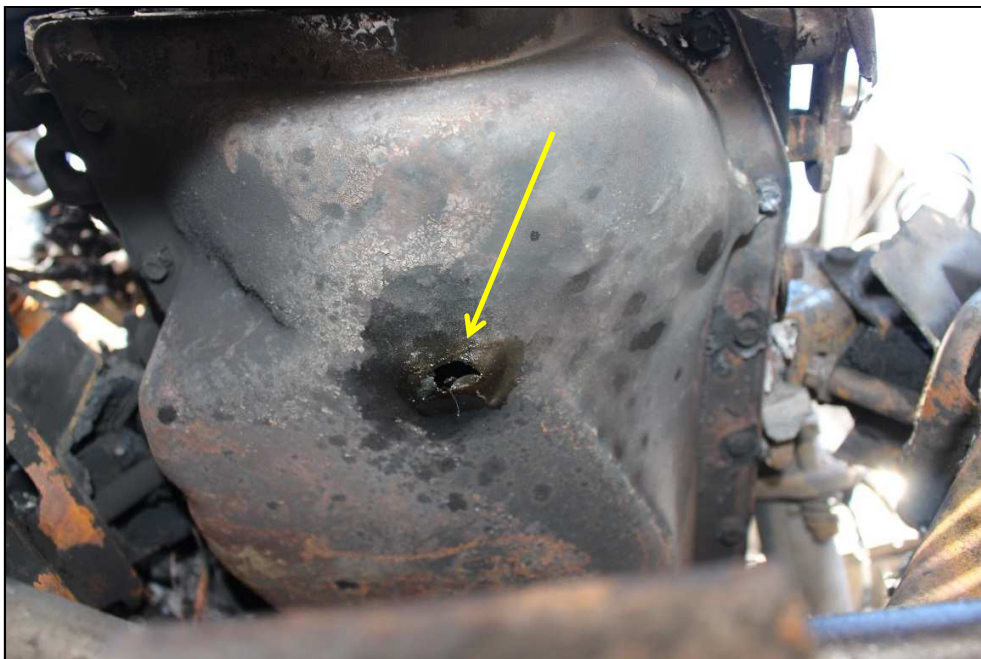
Photograph 4

Hole in engine oil pan, yellow arrow.

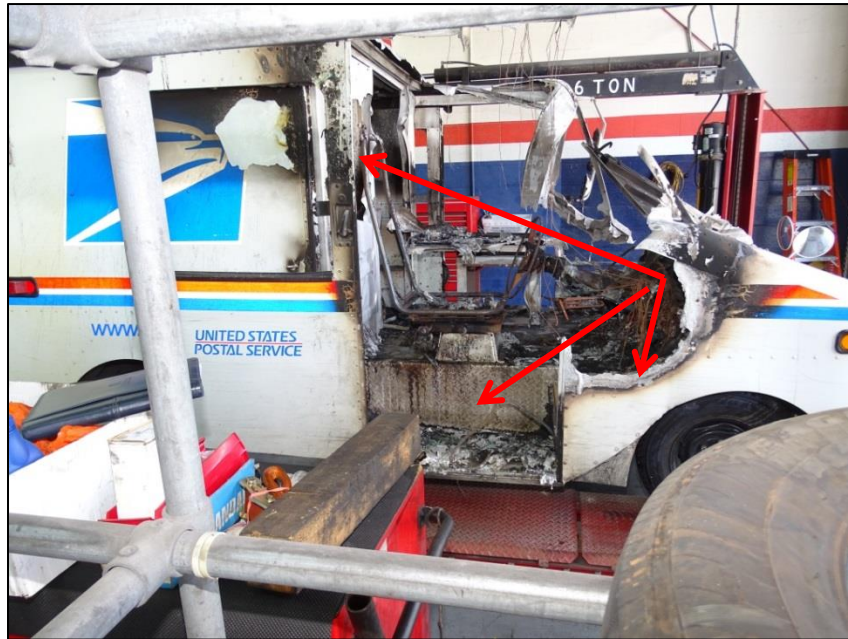
Photograph 3

View of the driver side of the vehicle. Note the direction of fire travel.

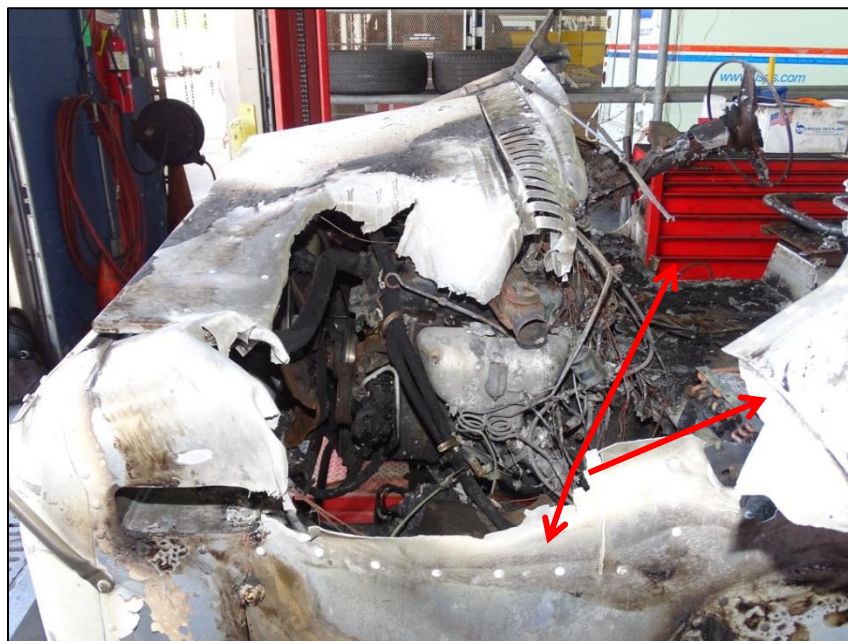
Photograph 4

View of the fire patterns on the hood of the vehicle. Note the direction of fire travel.

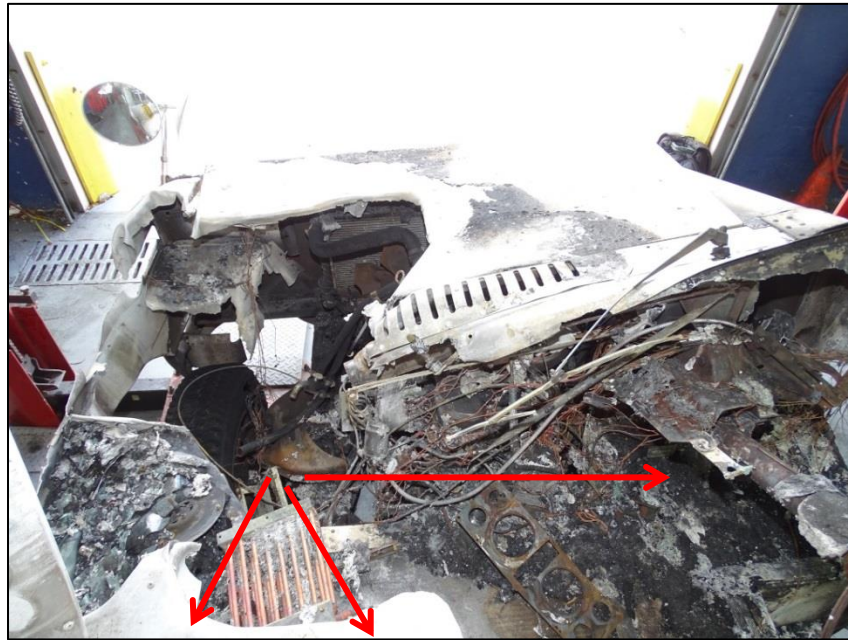
Photograph 5

View from the operator's compartment showing the direction of fire spread. Note the bulkhead was penetrated by the fire on the mail side of the compartment.

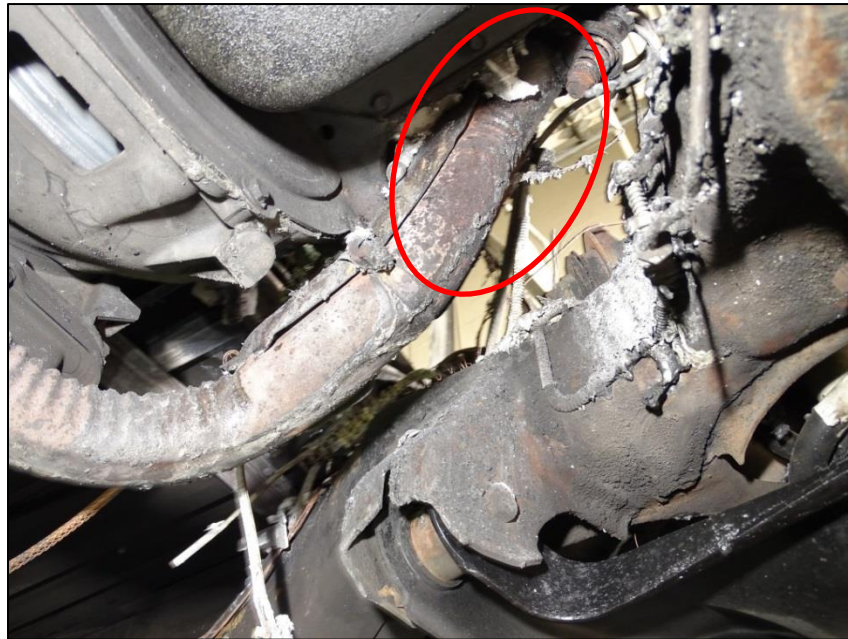
Photograph 9

View from the underside showing the probable ignition point on the exhaust pipe.

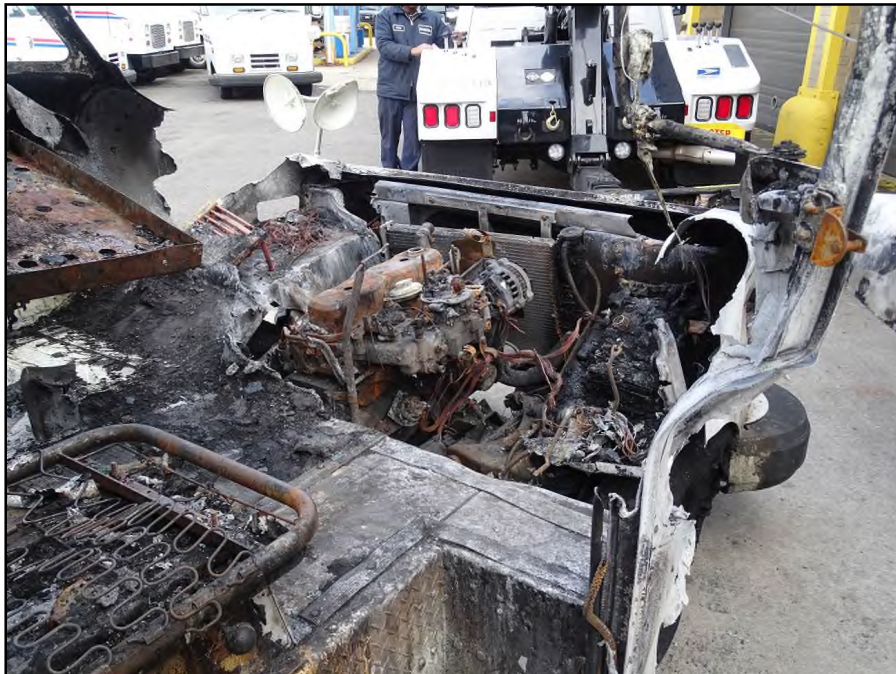
Photograph 8

Area of origin.

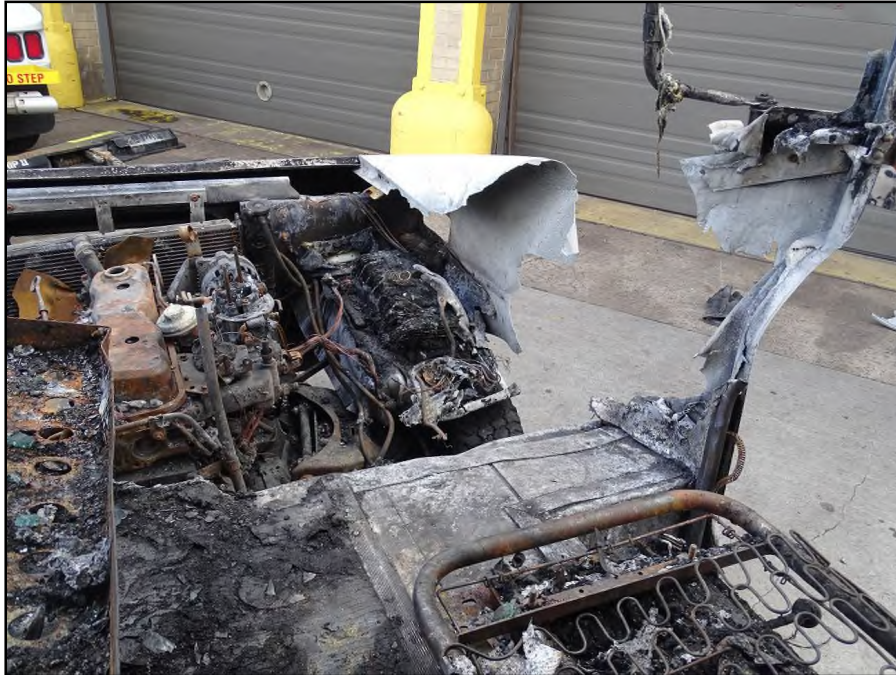
Photograph 9
Area of origin.

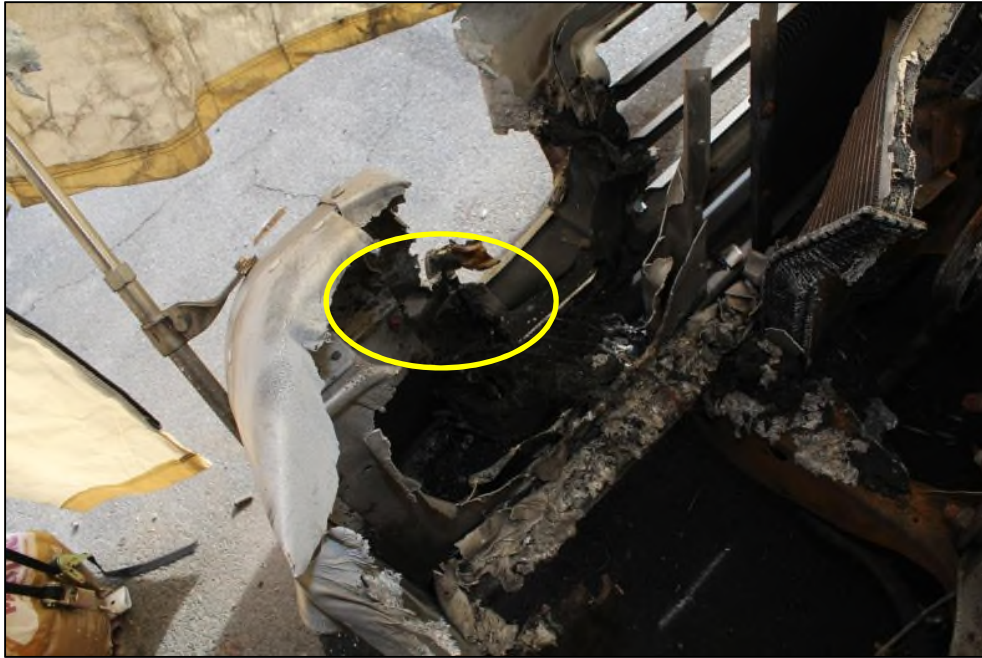
Photograph 3

Location where the vapor canister for the EVAP system had been located.

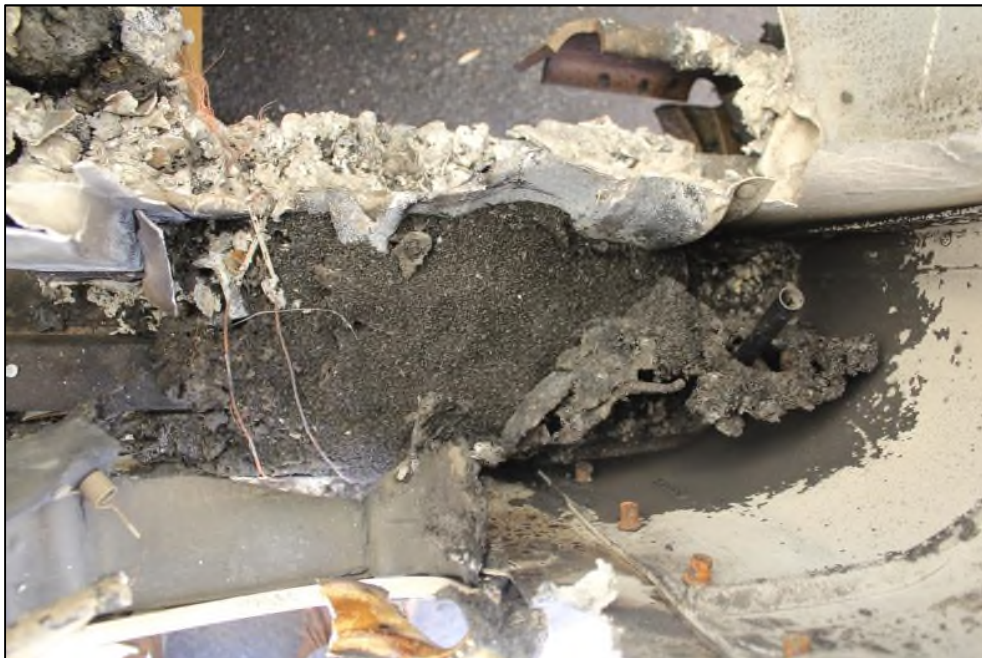
Photograph 4

Charcoal on the frame below the area where the vapor canister had been located.

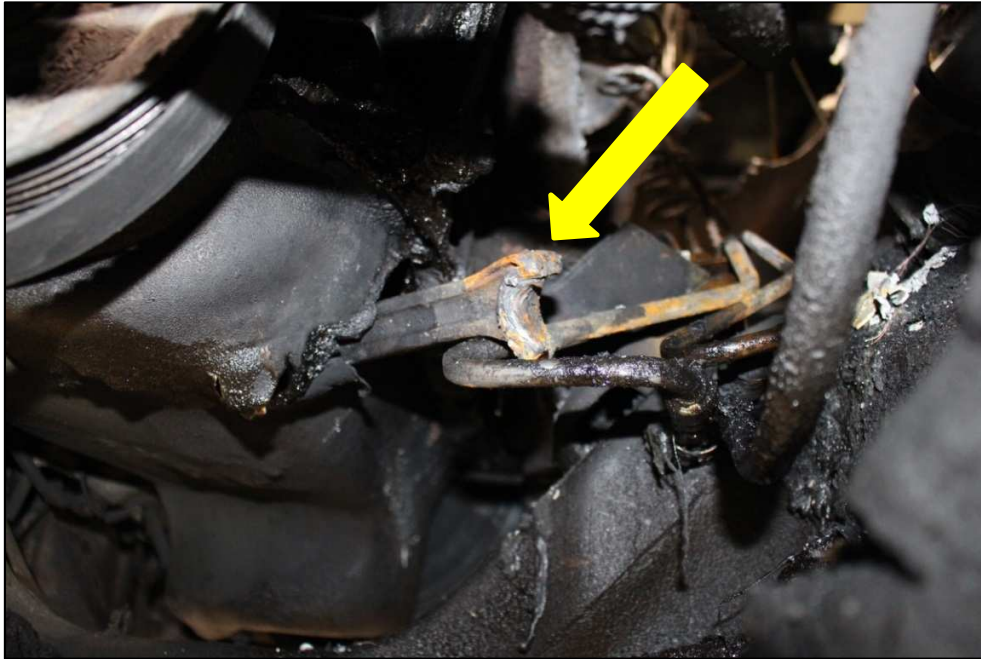
Photograph 5

Examination of the undercarriage revealed evidence that a catastrophic engine failure had occurred. We observed that a piston connecting rod had broken and had been propelled through the left side of the engine oil pan. The piston rod struck and dislodged a fuel line from a fitting on the left side of the engine. We observed fire patterns that indicated the fire originated in this area. The involved LLV was mounted on a GM frame.

The broken piston rod dislodged a fuel line from a fuel fitting which allowed gasoline to escape the fuel line and engine oil to escape onto the hot surface of the operating unit potentially contributing to the fuel load.

View of the broken piston rod (area of origin).

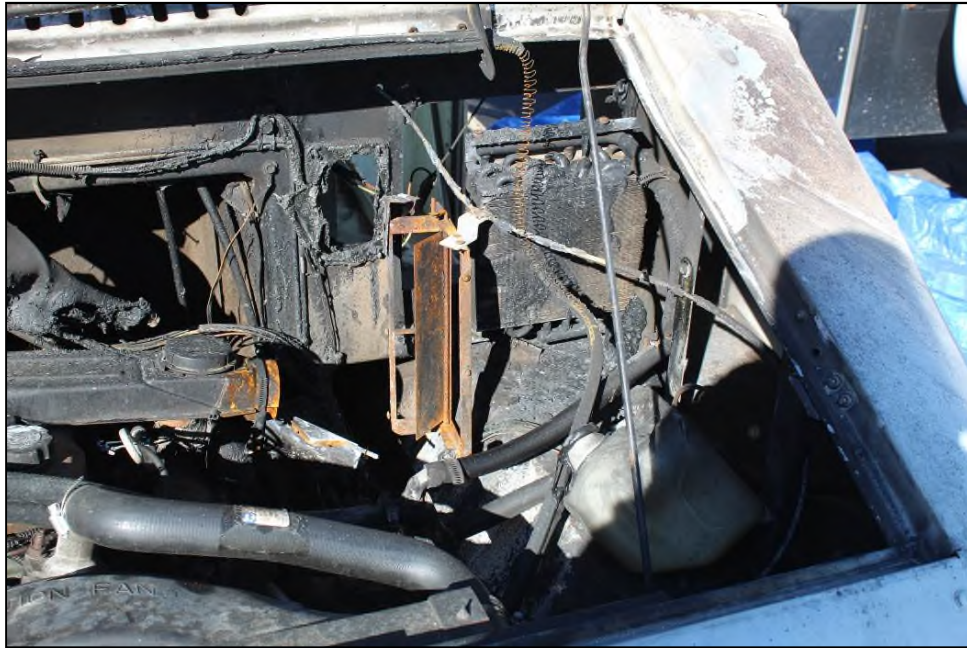
Photograph 5

1. The vehicle sustained moderate fire damage to the left side of the engine compartment and the left side of the bulkhead.

Fire damage to the engine compartment where the blower motor had been mounted.

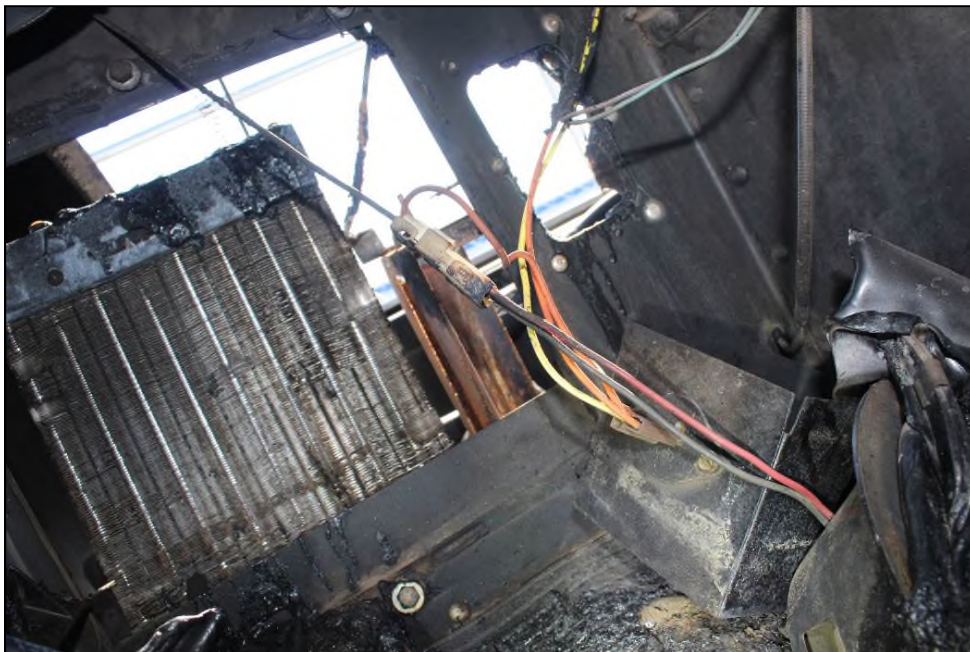
Photograph 6

Damage to the interior bulkhead where the blower motor had been mounted.
